RE: 14 Perkins Avenue

PLAN OF LAND
IN
HAMPTON, NH

SHOWING
A EXISTING DWELLING
AT
14 PERKINS AVENUE

Subject Photo Page

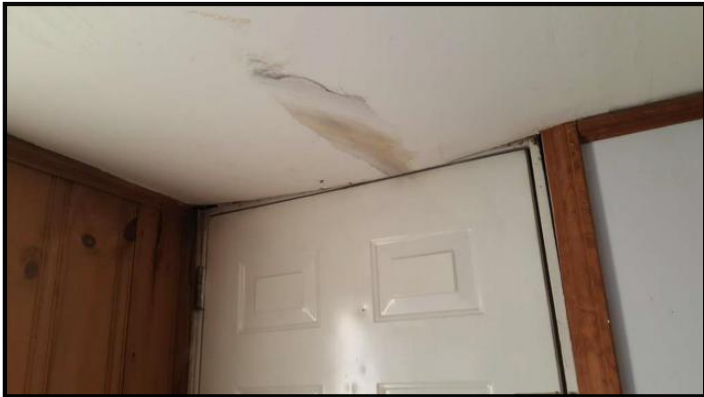
Front Door Damage
ceiling dry wall coming down cost to cure
unknown maybe water damage

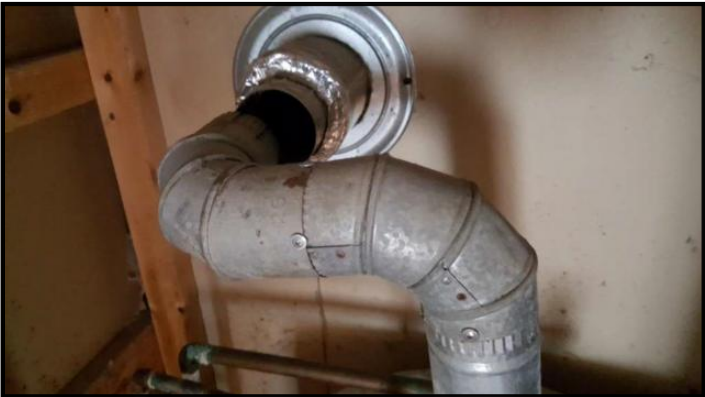
Water Tank exhaust Not Hooked Up

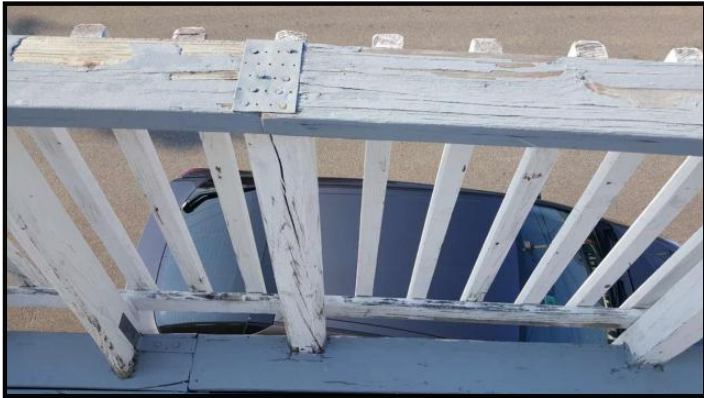
Deck may need repair
contractors estimate needed

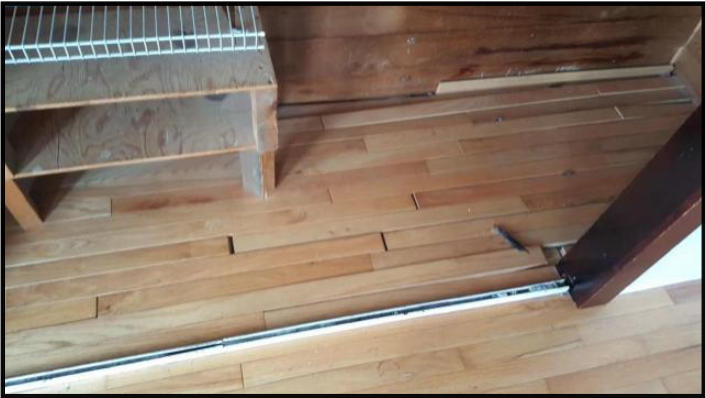
Floor Boards water Damage
contractors estimate needed

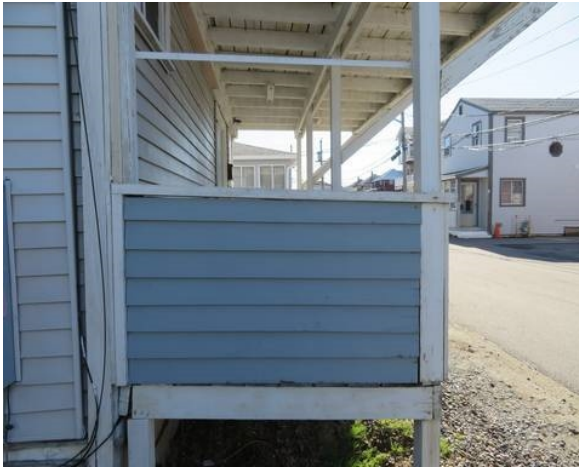
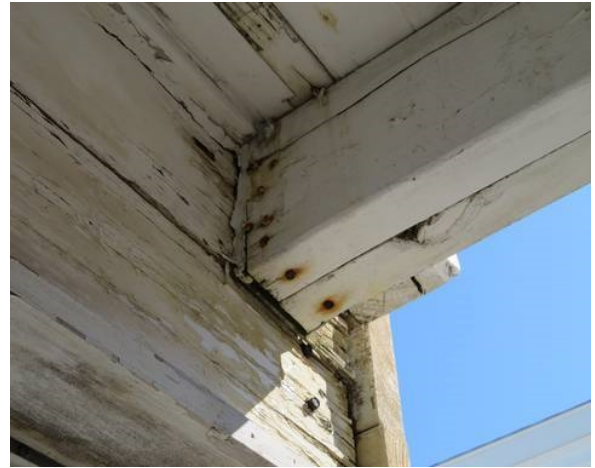
The right end of the ledger board on the upper deck (as faced from the road) is rotted approximately 12" in from the outer end. The joist hanger for the most outside support is also missing. Recommend consulting with a contractor to remove the damaged portion and repair as required.

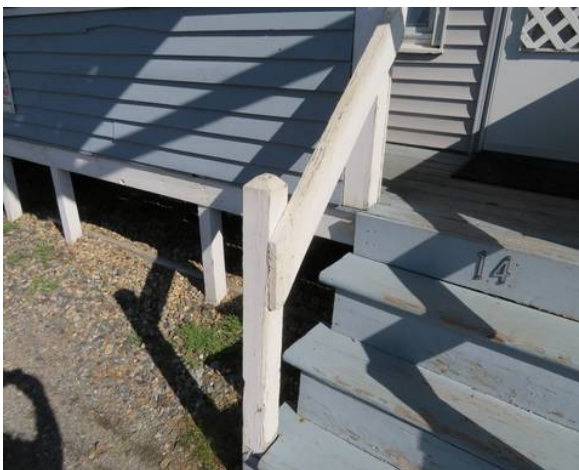
The railing structure feels un-secure (excessive "play"). Consult with a qualified contractor to assess the support structure and tighten / supplement as required to improve the stability of the system.

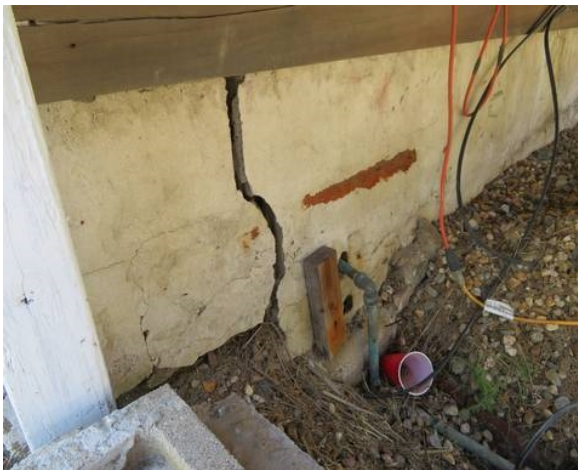
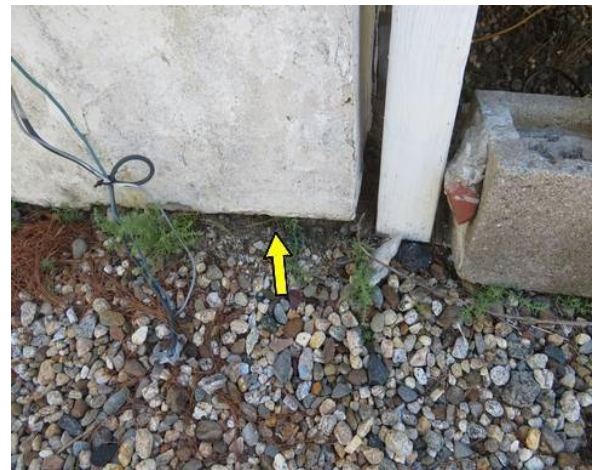
Front right corner as facing house from the road has a significant vertical crack. It appears to be the result of concrete / masonry block deterioration in the area. Consult with a structural engineer to evaluate the structure and make recommendations for repair.

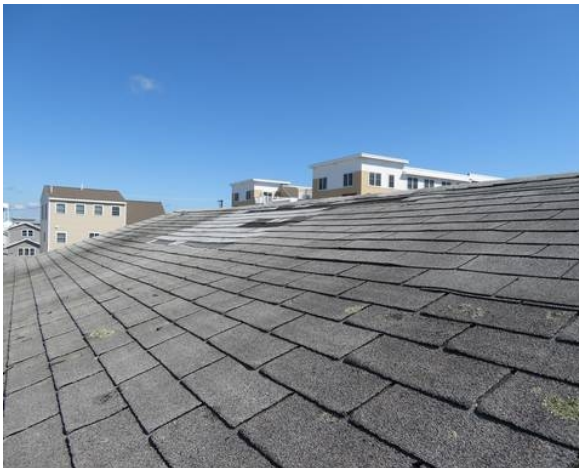
Budget to replace shingles showing uneven wear conditions relative to age. Shingle failure is unpredictable.

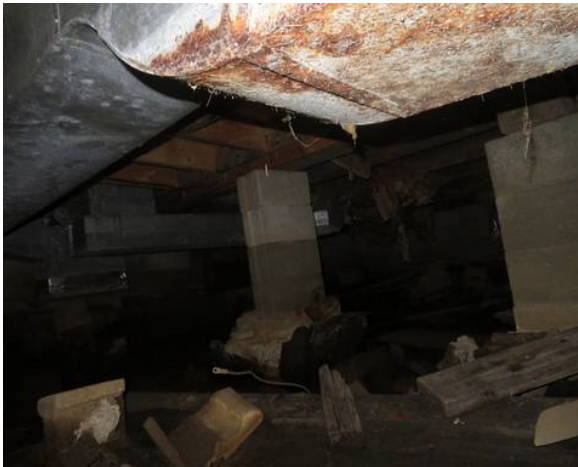
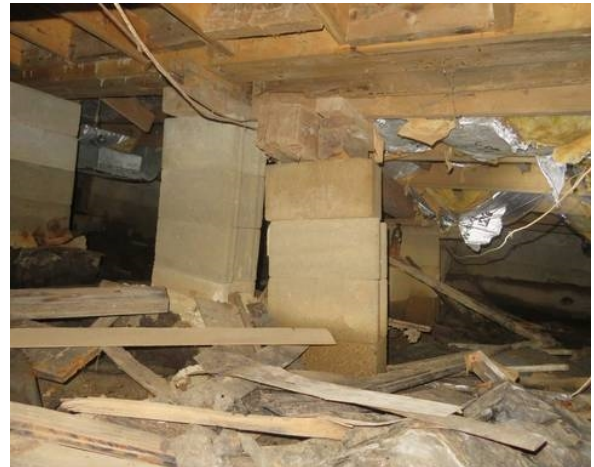
Several of the concrete block supports have settled and are leaning. In addition, the block piers do not appear to be supported by footings. Consult with a structural engineer, or qualified contractor to evaluate the basement support structure and fortify / reinforce as required.

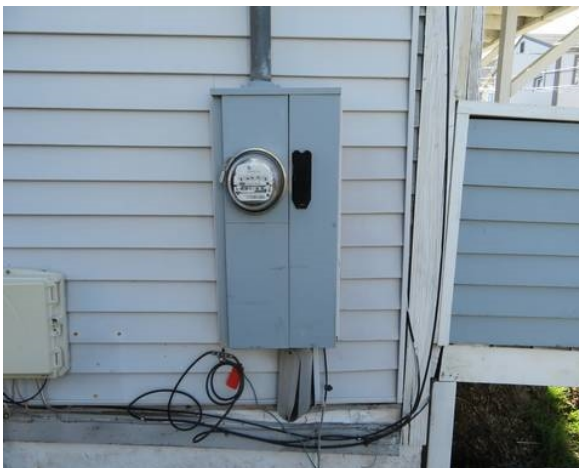
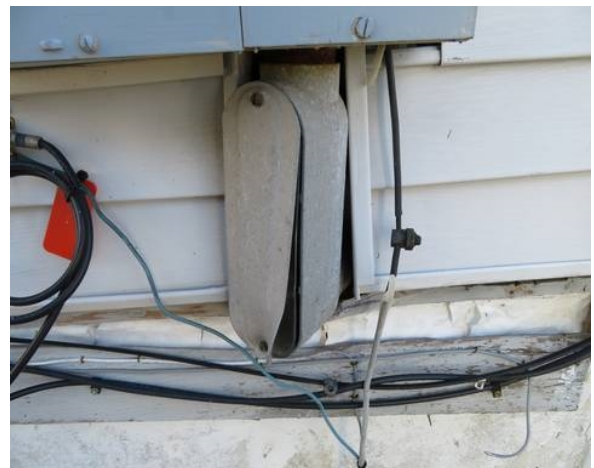
Conduit damage under meter. Recommend consulting with an electrician to repair as required.

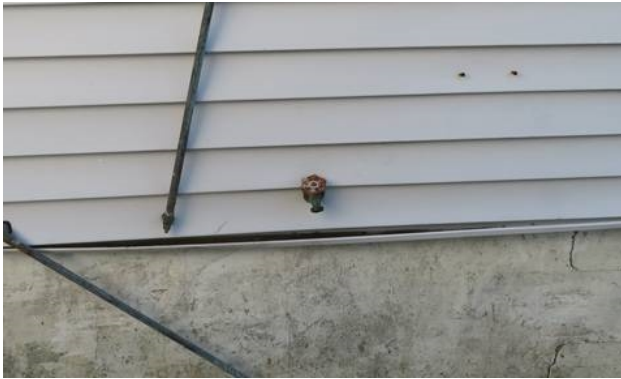
Determine cause of leaking and correct as required to reduce secondary water damages

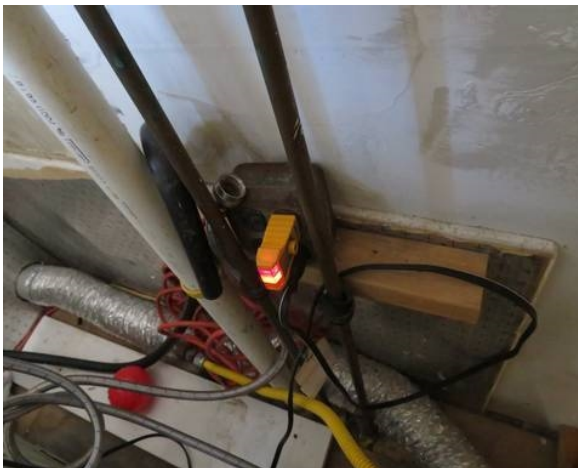
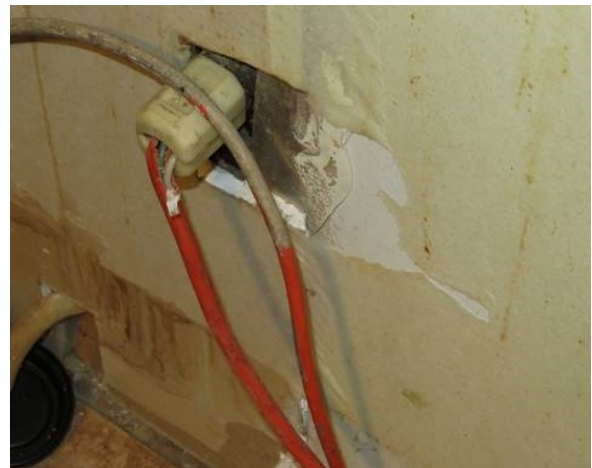
"Hot/Neutral Reversed" was indicated when tested on one receptacle. Consult with a qualified electrician to repair.

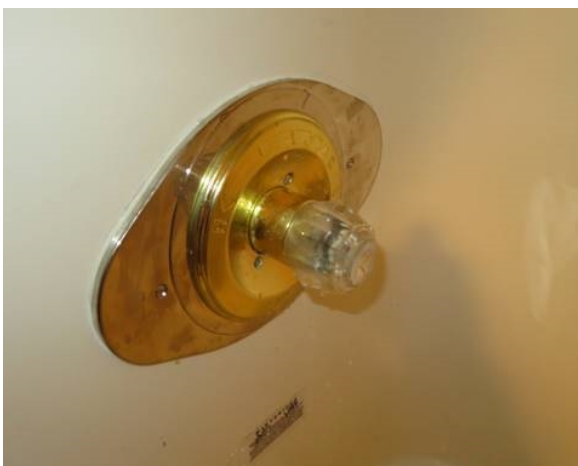
It appears as though the hot and cold are reversed on the mixer valve. recommend consulting with a qualified plumber to evaluate and correct as required.

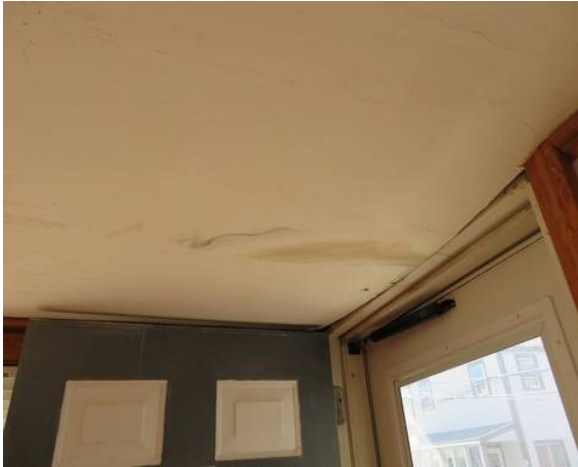
Drywall ceiling is sagging in a couple locations. Re-secure, patch and paint as required.

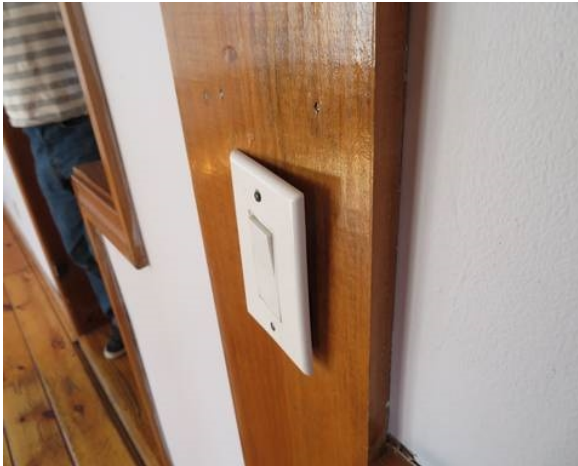
Switch plate does not sit flush against the wall. Consult with an electrician to evaluate and repair as required.

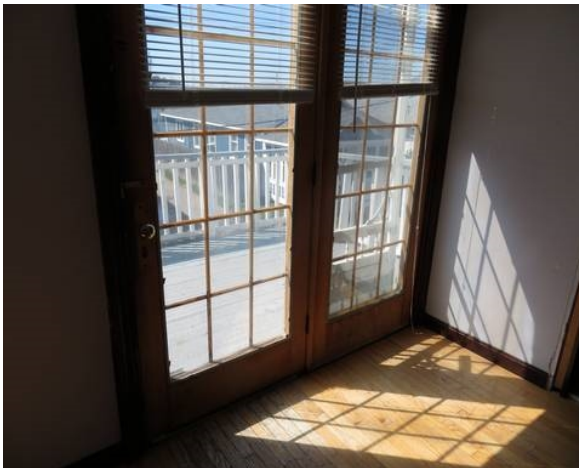
Doorknob hardware is not tight. Secure hardware to regain proper function.

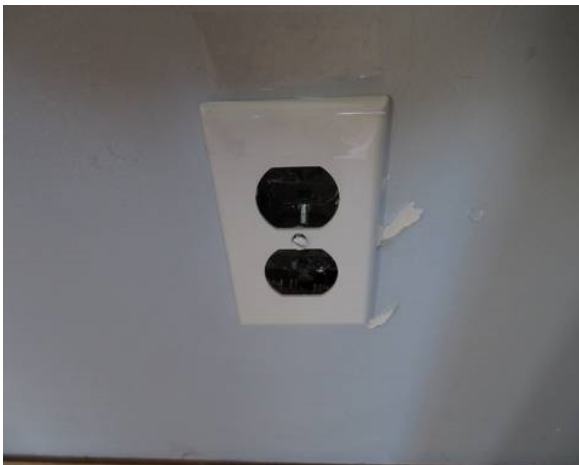
Receptacles are recessed from cover plates by approximately 1/2". Recommend consulting with an electrician to evaluate / correct as required.
